Assessment of the status of river pools in the Avon catchment

Water resource management series

Report No. WRM 47
December 2007

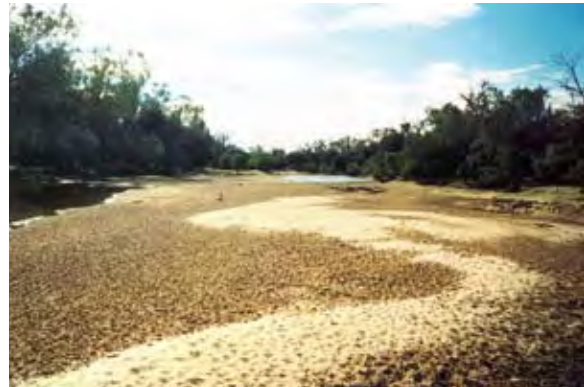
Deepdale pool is approximately 2 km upstream of the Folewood Road and River Road intersection. This pool marks the downstream extent of the river training scheme. Prior to the RTS, Deepdale Pool was used for swimming, fishing (for cobbler and mullet) and was suitable for stock water. The pool filled with sediment soon after the RTS was completed in this section and the survey of 1977 noted the pool was full (WRC and AWC, 2002a).

*Deepdale Pool filled with sediment
(Photo courtesy Viv Read)*

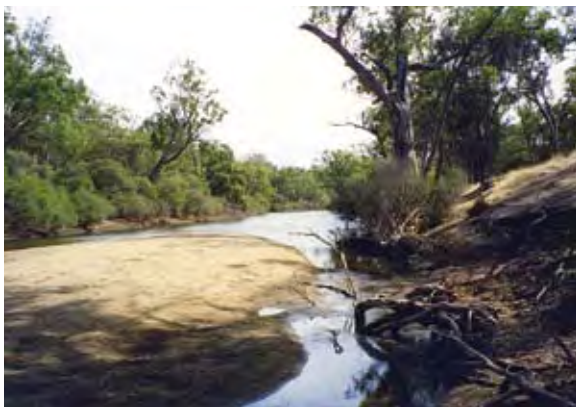
*Sediment filling Long Pool
(Photo courtesy Viv Read)*

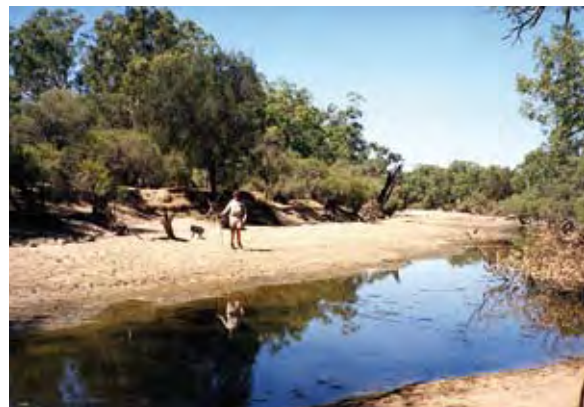
*Sediment in the downstream end of Jimperding Pool
(Photo courtesy Viv Read)*

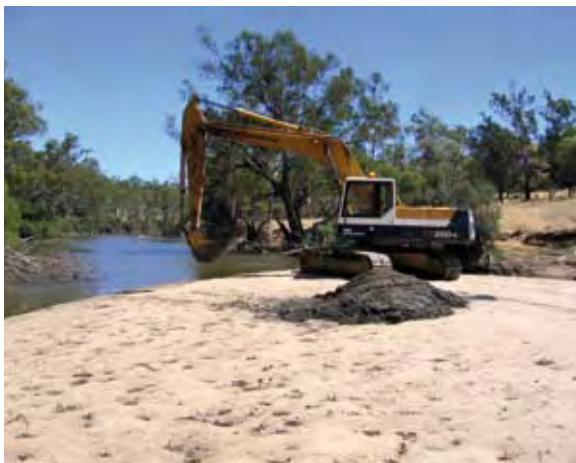
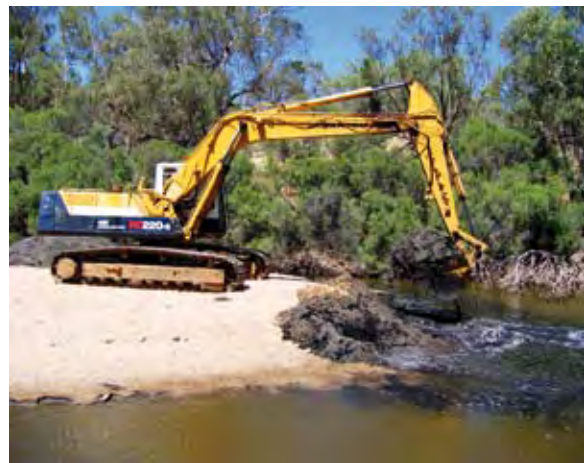
*Sediment extraction at Long Pool, Feb 2005
(Photo courtesy Bernard Kelly)*

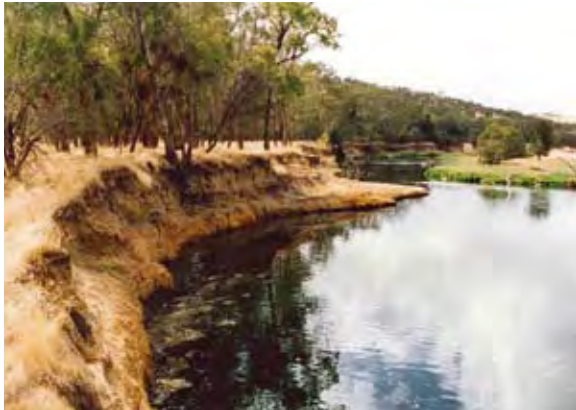
Red Banks Pool is downstream of the Bindi-Bindi Toodyay Road bridge. This is the only major pool on the Avon River that is circular due to active erosional processes caused by a conspicuous rock bar. There is only limited information available about this pool, however it is known that the pool was formed by the substantial raising in the late 1950s of the old Whitefield's Crossing (now known as Extracts Weir) to provide water for a tanning factory. The pool was popular for swimming. It remains deep (approximately 5 m) and has very steep (cliff-face) banks (5–8 m above the water level) (Davies et al. 1996). It is likely that this pool is self-scouring and may increase in size with time.

*Red Banks Pool - self scouring
(Photo courtesy Viv Read)*

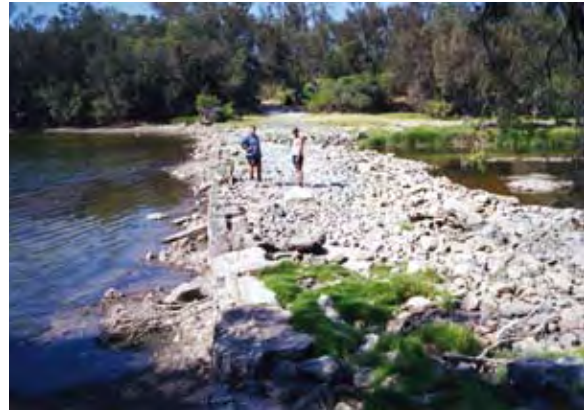
The original crossing at the downstream end of Glen Avon Pool was known as McDermott's Crossing. Last used in the 1920s, it was a natural rock bar which was raised by half a metre in the 1970s to protect Glen Avon Pool and the Katrine Bridge footings. The pool is maintained by this constructed weir. Removal of the weir would cause massive channel erosion that would destroy the pool and would probably mobilise sediments now contained within Katrine Pool. The weir has been damaged during past flood events and has been repaired on a number of occasions.

*Weir at the downstream end of Glen Avon Pool
(Photo courtesy Bernard Kelly)*

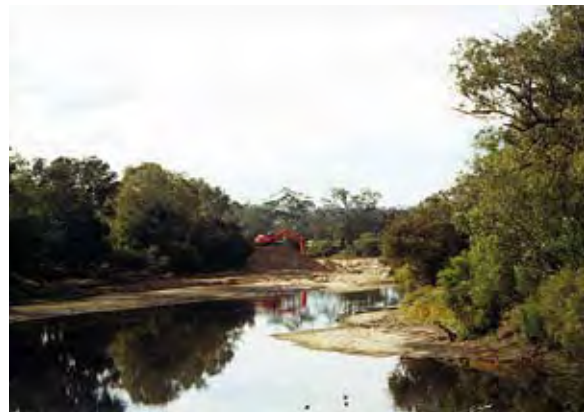
*Sediment removal from Katrine Pool looking
upstream (Photo courtesy Martin Revell)*

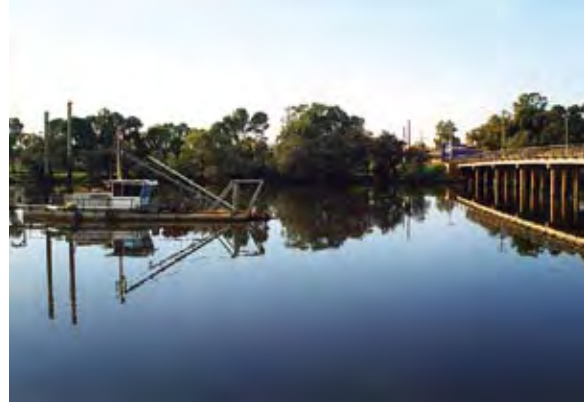
*Dredge in Northam Town Pool downstream of the Peel Street Bridge, August 2000
(Photo courtesy Martin Revell)*

As a result of public concern for the pool and recommendations made in the management plan, a dredging project was undertaken by the Town of Northam in partnership with Department of Water, formerly Water and Rivers Commission. 50 000 m³ of sediment was removed from the Town Pool in August 2000 to deepen the pool and improve the overall health and aesthetics of the pool. Sediment was removed from the left hand side of the channel from the Avon bridge to the Peel St Bridge and the width of the channel was dredged downstream of the Peel Street bridge to the weir. The sediment removed from the pool was not suitable for resale and was stockpiled offsite.

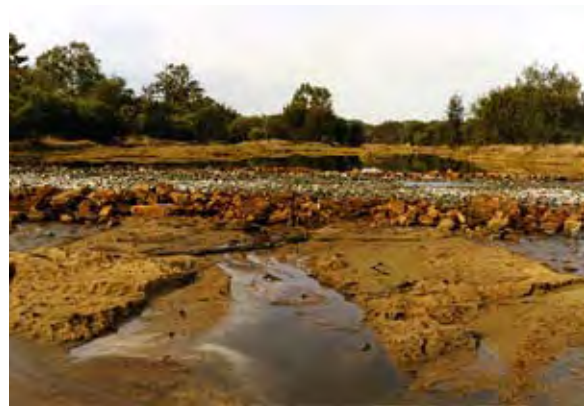
Riffle constructed upstream of Burlong Pool to trap sediment (Photo courtesy Bernard Kelly)

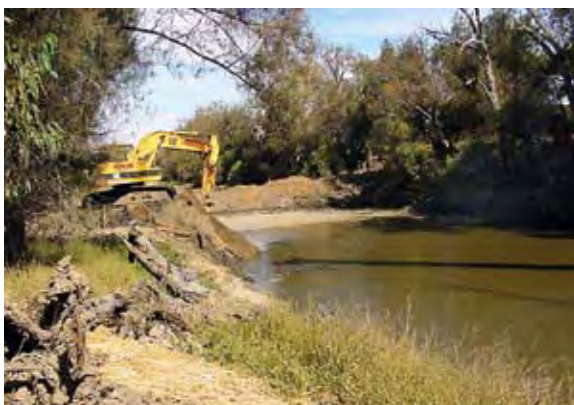
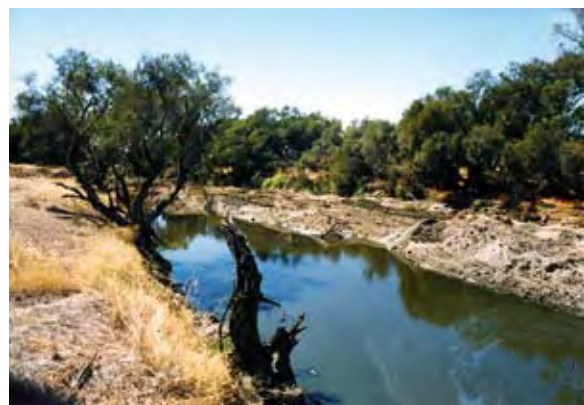
*Excavation of Railway Pool in 2002
(Photo courtesy Nina King)*

*Restoring the depth to Railway Pool 2002
(Photo courtesy Nina King)*

In April 2002, 100 m of the river pool was excavated on the upstream side of the railway bridge and 3300 m³ of coarse sediment was extracted from the pool. In April 2006 Department of Water surveyed the pool and observed a sand slug in the upstream section of the pool. Future work at this pool could include revegetation work to stabilise the banks that were disturbed during excavation.

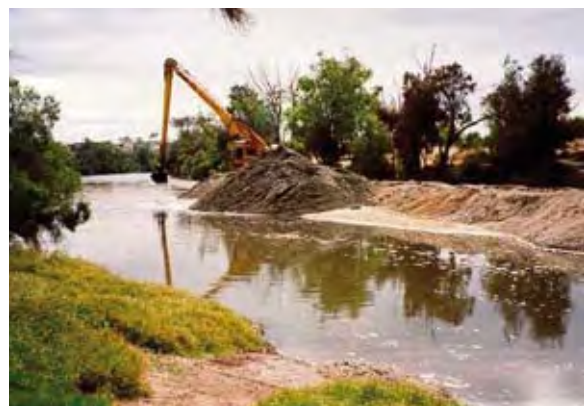
Removal of sediment from Gwambygine Pool, 1999 (Photo courtesy Peter Kata)

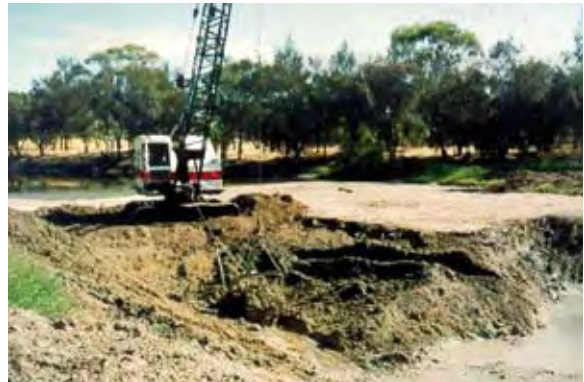
*A dragline removing sediment from Beverley Town Pool in 1993
(Photo courtesy Fred Bremner)*

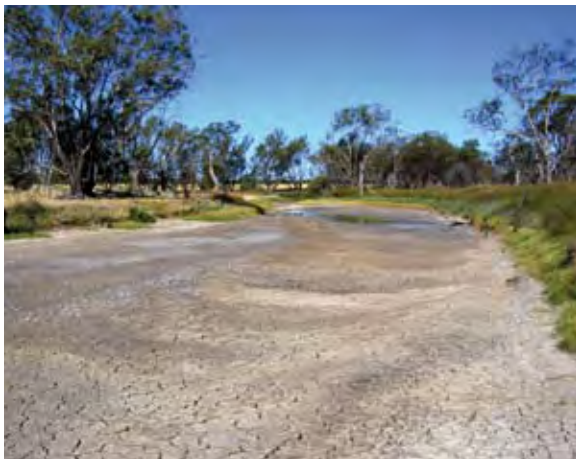
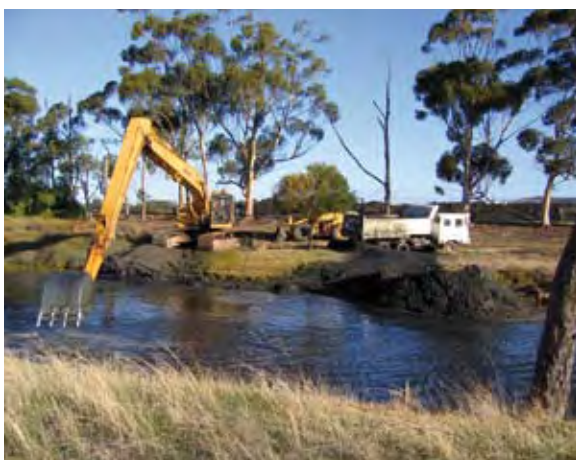
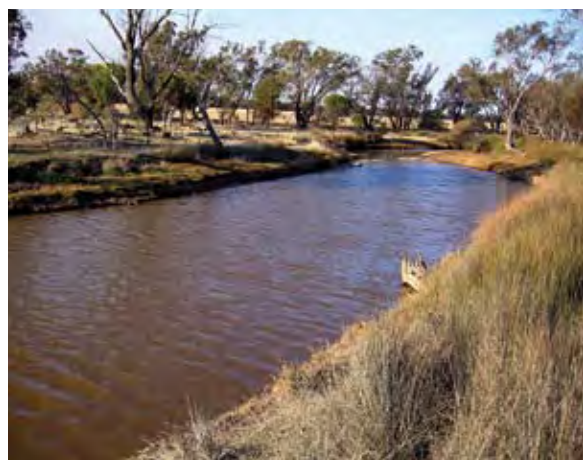
One Mile Pool looking upstream prior to sediment removal. (Photo courtesy Prue Dufty)

Long-reach excavator removing sediment from the pool. (Photo courtesy Michael Allen)

*One Mile Pool with depth restored after sediment removal
(Photo courtesy Michael Allen)*

With plans in place to minimise the impacts on water quality by waste-water being discharged from the treatment plant, recovery of One Mile Pool began in May 2007. Approximately 3000 m³ of coarse sediment was removed from the pool using a long-reach excavator in an effort to restore the depth and enhance the ecological and recreational values of the pool. The Department of Water has also developed a revegetation plan for this site. Planting began in July 2007 in partnership with the Seabrook Aboriginal Corporation.

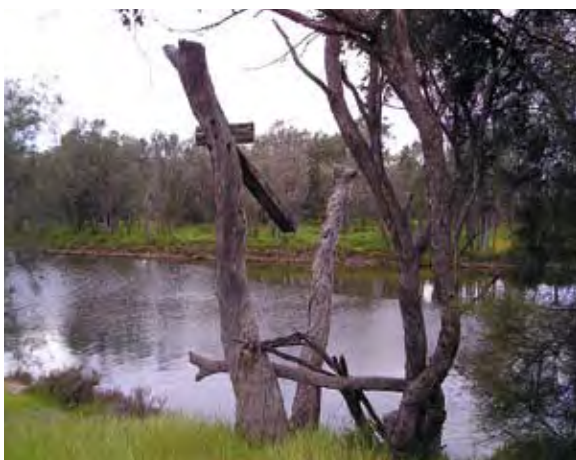
Remnants of a diving board structure at Dwarlack Pool (Photo courtesy Viv Read)

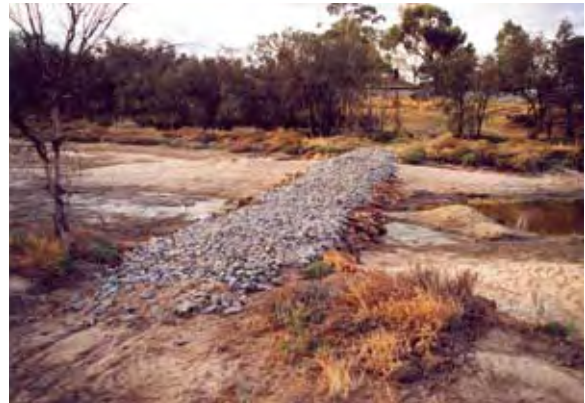
*Riffle constructed upstream of Beverley Town Pool to trap sediment
(Photo courtesy Bernard Kelly)*

In 1999 a Sediment Management Plan was developed for the pool. A riffle was also constructed upstream of the pool to trap sediments and minimise sedimentation to the main pool area.

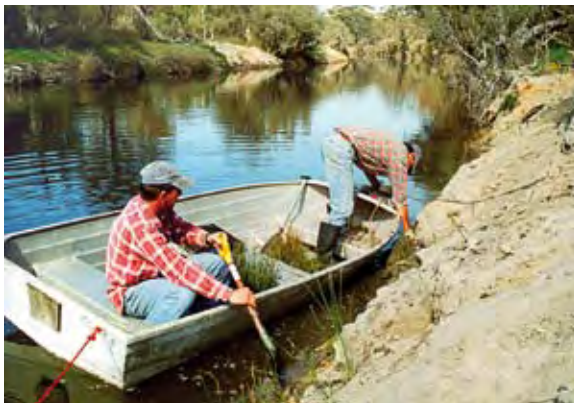
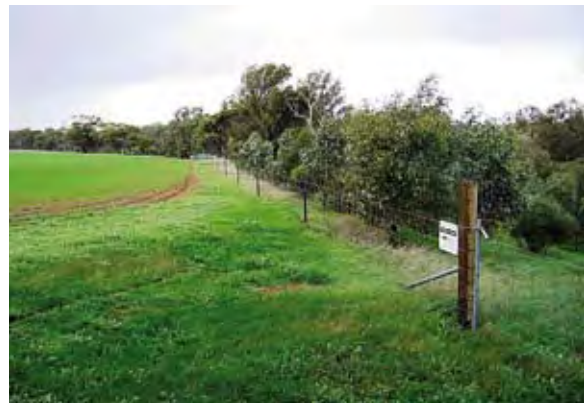
*Revegetation work on the edge of Boyagarra Pool to stabilise the banks
(Photo courtesy Brendan Oversby)*

*Fencing at Boyagarra Pool to protect riparian vegetation and exclude stock
(Photo courtesy Bernard Kelly)*
