Assessment of the status of river pools in the Avon catchment

Water resource management series

Report No. WRM 47
December 2007

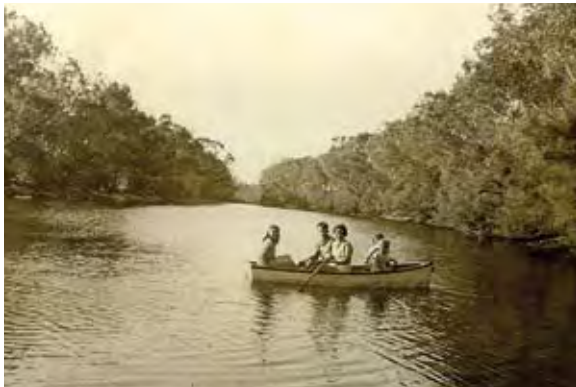
Deepdale pool is approximately 2 km upstream of the Folewood Road and River Road intersection. This pool marks the downstream extent of the river training scheme. Prior to the RTS, Deepdale Pool was used for swimming, fishing (for cobbler and mullet) and was suitable for stock water. The pool filled with sediment soon after the RTS was completed in this section and the survey of 1977 noted the pool was full (WRC and AWC, 2002a).

The sediment in this pool is described as sand and although there has been no nutrient analysis, the sediment nutrient load can be assumed to be quite low (Davies et al. 1996). The ecological value of the pool is considered to be low given it is filled with sediment and can no longer sustain a healthy aquatic ecosystem. Limited access to the site by machinery also dictates this pool's lower priority for recovery.

*Deepdale Pool in 1950s prior to RTS
(Photo courtesy Helen Heath)*

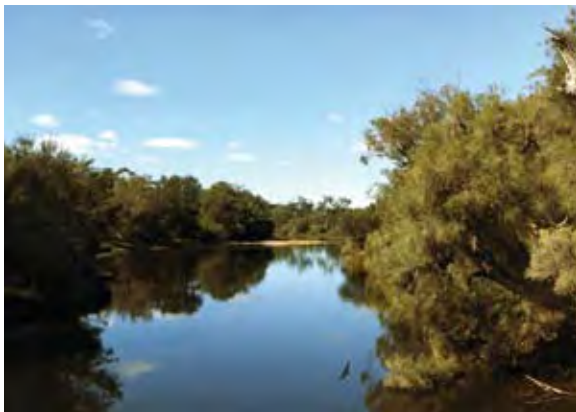
*Katrine Pool
(Photo courtesy Martin Revell)*

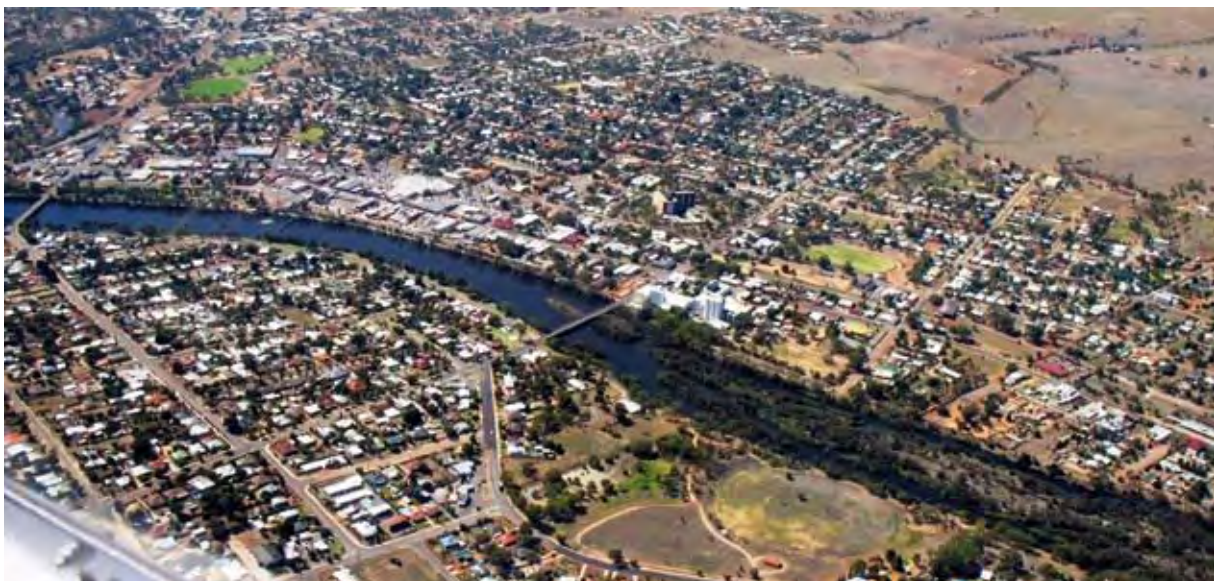
Bed sediment of the pool is almost entirely silt/clay with a higher sand content closer to the sand bars (Davies et al. 1996). Total phosphorous in the water varies from 0.10 mg/L to 0.17 mg/L. There is a high nutrient content in the sediments which is to

Aerial photograph of 'West Northam Forest' (on the right), an untrained section of the Avon River, with the Northam Town Pool (on the left) (Photo courtesy of Bernard Kelly)

be expected from clay/organic matter (Davies et al. 1996). Algal blooms are common in the Town Pool, particularly in the summer months when the flushing is reduced.

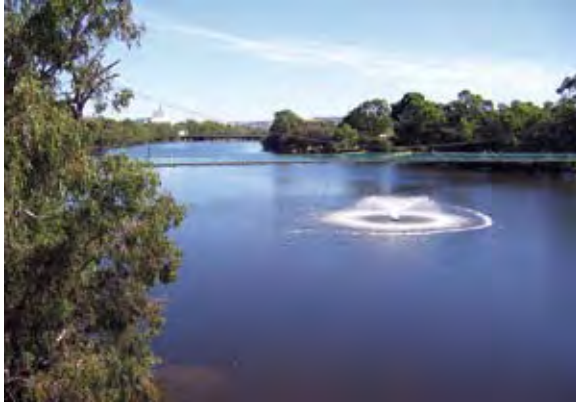
*Aerator on Northam Town Pool looking upstream, 2006
(Photo courtesy Rebekah Esszig)*

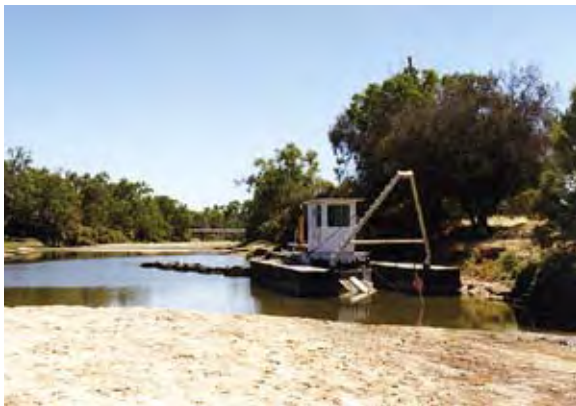
*Dredge at Burlong Pool
(Photo courtesy Bernard Kelly)*

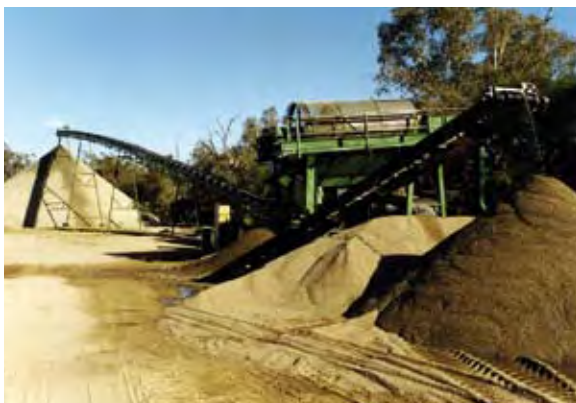
Screening plant which receives sand from the Burlong dredge (Photo courtesy Bernard Kelly)

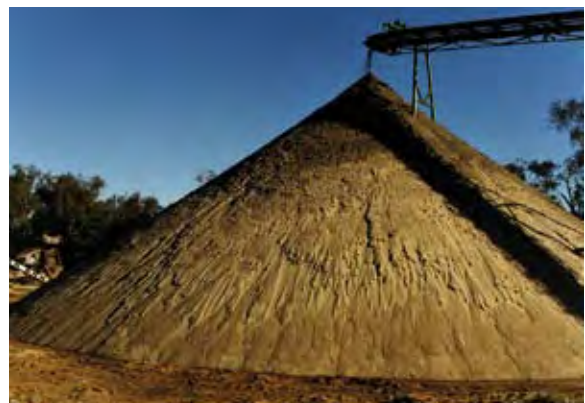
Stockpile of sediment removed from Burlong Pool in 2000 (Photo courtesy Bernard Kelly)

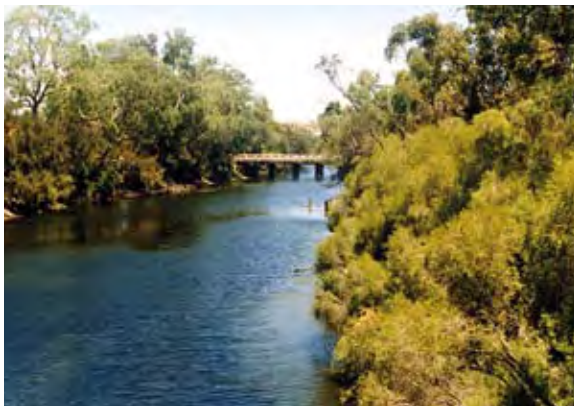
Reconstruction of a stone crossing (at the old Mongers Bridge site) was carried out by the WRC during the autumn of 2002, in partnership with Green Corps and the Shire of York. Repairing the riffle effectively raised the level of Blands Pool by 400 mm.

*Blands Pool in York
(Photo courtesy Bernard Kelly)*

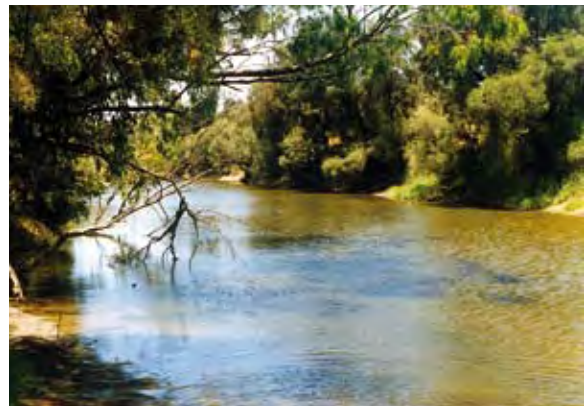
This pool is immediately upstream of the railway bridge, 1 km from the York townsite. Railway Pool was not surveyed in the 1996 survey. Railway Pool is maintained to trap sediment, reducing the risk of infill for Blands Pool. The Department of Water has surveyed the pool and found the pool is approximately 170 m long with an average depth > 2 m and almost half filled with coarse sand.

In April 2002, 100 m of the river pool was excavated on the upstream side of the railway bridge and 3300 m³ of coarse sediment was extracted from the pool. In April 2006 Department of Water surveyed the pool and observed a sand slug in the upstream section of the pool. Future work at this pool could include revegetation work to stabilise the banks that were disturbed during excavation.

*Railway Pool looking upstream
(Photo courtesy Nina King)*

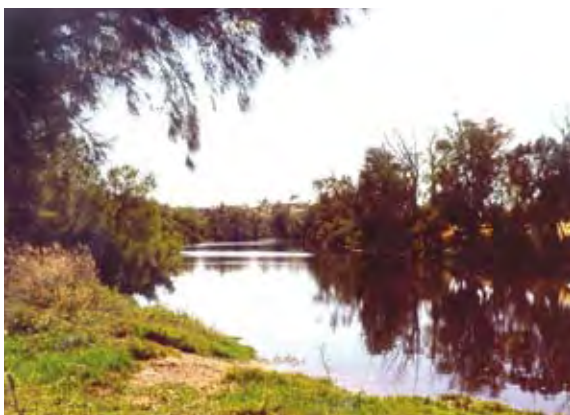
Gwambygine Pool (Photo courtesy Peter Kata)

Gwambygine Pool is located 13 km south of York. It is one of the few Avon River pools remaining in good condition. The pool has a maximum depth of 4 m, making it the deepest pool upstream of York (WRC and ARMA, 2001a). Gwambygine Park is located on a reserve adjacent to the Avon River just downstream of the pool. The park has excellent visitor facilities. Gwambygine Park is an 'Avon Ascent' site established for environmental education.

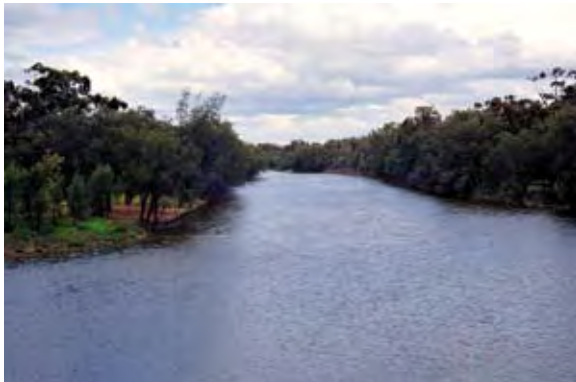
*Beverley Town Pool in looking upstream from Vincent Street bridge
(Photo courtesy Fred Bremner)*

In 1999 a Sediment Management Plan was developed for the pool. A riffle was also constructed upstream of the pool to trap sediments and minimise sedimentation to the main pool area.

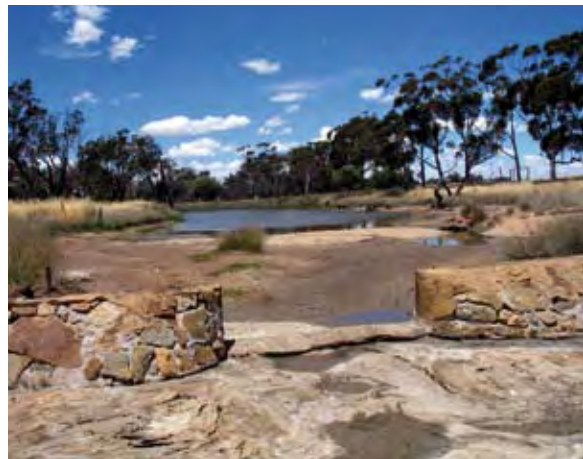
Weir-like structure at the downstream end of One Mile Pool. (Photo courtesy Prue Dufty)

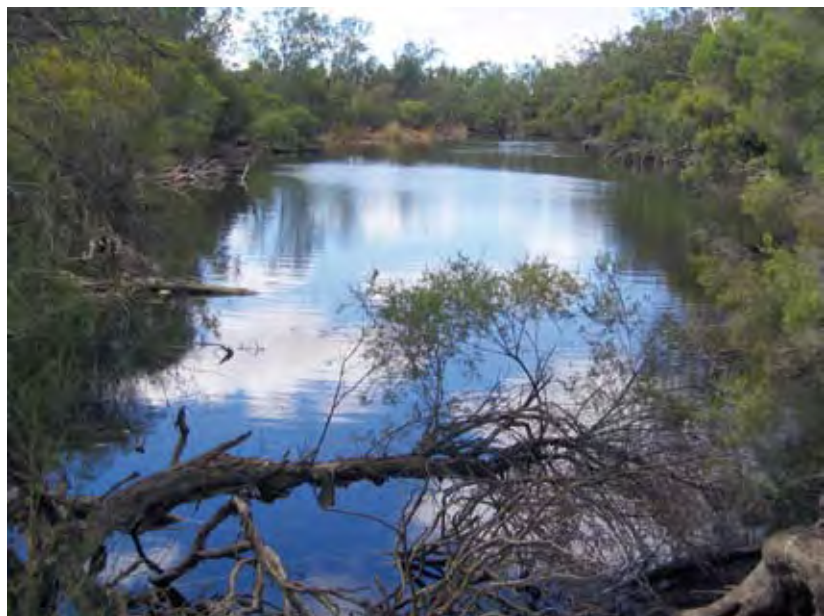
Mile Pool (Photo courtesy Kate Gole)

Mile Pool and Mandiakon Pool are fed by relatively-fresh groundwater, emanating from deep sandy soils unaffected by salinity (Department of Water, 2006). Protection of groundwater is essential for the long-term health of these pools and should be considered in future management strategies.

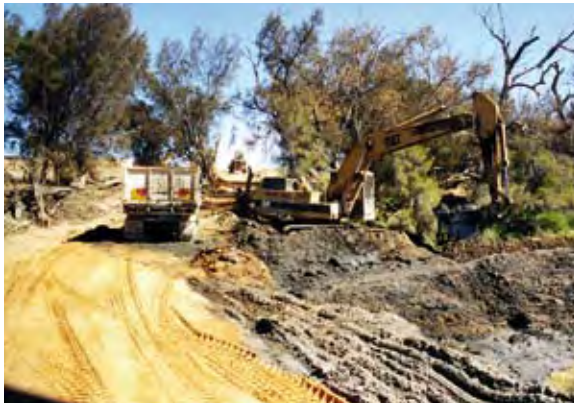
*Sediment being removed from Railway Pool and transported off site
(Photo courtesy Nina King)*
